Property Inspection Report

140 Lupfer Avenue, Whitefish, MT

Inspection Date: September 26, 2018

Report Number: 180926

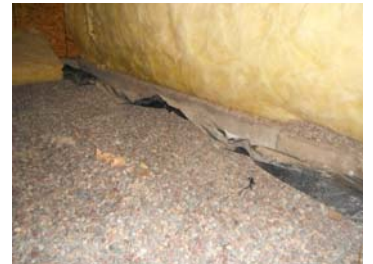
- **Repair:** Disconnected ductwork in the crawl space should be repaired. Disconnected duct work increases heating/cooling costs, can cause building damage, and in some instances can be unsafe where combustion gases can be vented to the living area.
- **Improve:** The moisture barrier in the crawlspace is covered with several inches of sand/gravel. If water or moisture enters the crawlspace and the sand/gravel gets wet, it will evaporate the moisture over a long period of time, keeping the crawlspace damp. To help keep the crawlspace dry, the sand/gravel should be covered with another moisture barrier.

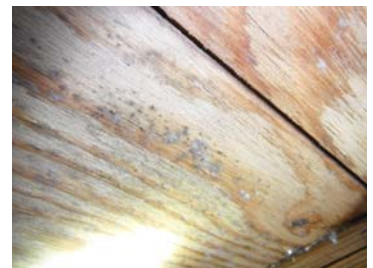
- **Monitor:** As in many buildings with crawlspaces, staining of the wood probably due to mold/mildew was found. This often occurs during construction before the roof is installed. When there is a good moisture barrier over the dirt, there is seldom a continuing moisture problem. From a structural standpoint, this staining has not caused a problem. Occasionally check these areas for additional moisture problems. If you have concerns about mold, it may be in your best interest to have a mold professional further evaluate this condition to determine what, if any further action is needed.

- **Repair:** The presence of mold on the floor structure may be an indication that the crawlspace ventilation is not performing adequately. Crawlspace usually need some sort of ventilation to prevent moisture buildup which may cause mold on the wood. Although there are numerous options and opinions when it comes to crawlspace venting, I believe the optimal method is to install a humidistatically controlled exhaust fan vented to the exterior, close the remaining exterior vents and install a transfer grille through the floor of the occupied area in the far corner of the crawlspace away from the exhaust fan.

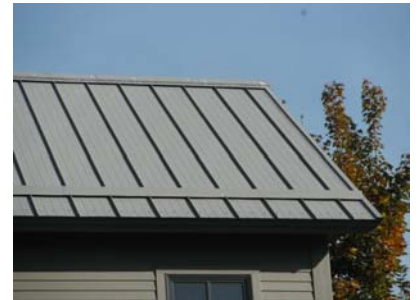
No necessary roofing repairs were visible.

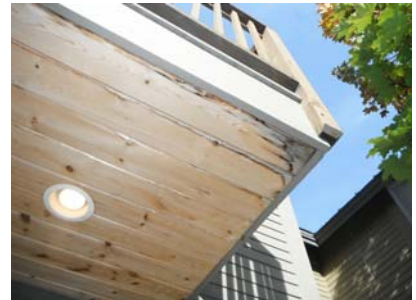
- **Repair:** The waterproof membrane on the deck appears to be leaking at the edges. Over time the leaks may cause damage to the deck structure. Repairs are recommended to prevent damage.

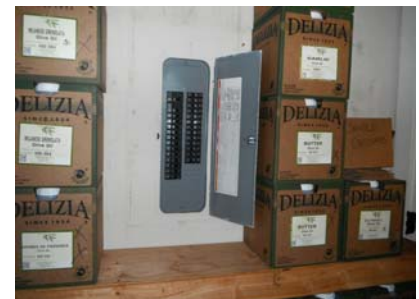
- **Improve:** Modern safety standards call for a clear space in front of the panel, but it is blocked by a shelf and items stored on the shelf. The cover plate of the panel could not be removed for an inspection of the interior of the panel.

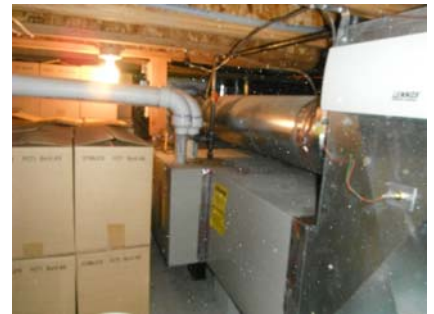
- **Improve:** Storage in front of the furnace prevented opening the furnace cabinet to inspect the furnace interior. Ideally, the area in front of the furnace should be kept clear to allow access for repair and service.

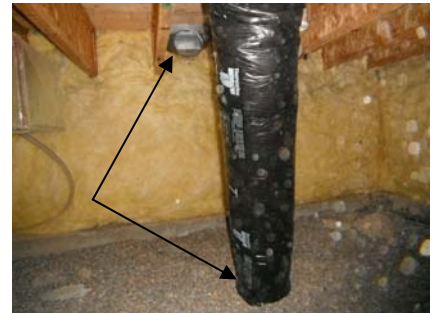
- **Repair:** The ductwork has become disconnected and should be repaired for better operation of the heating system.

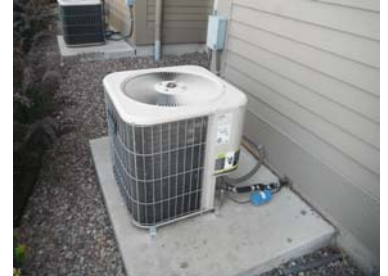
- **Monitor:** The thermostat would only adjust down to 70 degrees in the cooling mode. The indoor temperature was less than that so the system would not respond.

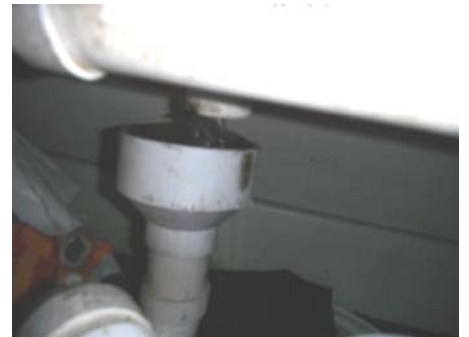
- **Repair:** The kitchen sink drain was leaking. The lower portion of the drain system does not appear to be able to handle all the water when the sink drains rapidly. This may be an indication that the grease/oil trap system is in need of cleaning. This should be corrected to prevent damage to the cabinet.
